# Rail Accident Report

## Boiler incident on the Kirklees Light Railway 3 July 2011

# Boiler incident on the Kirklees Light Railway

## 3 July 2011

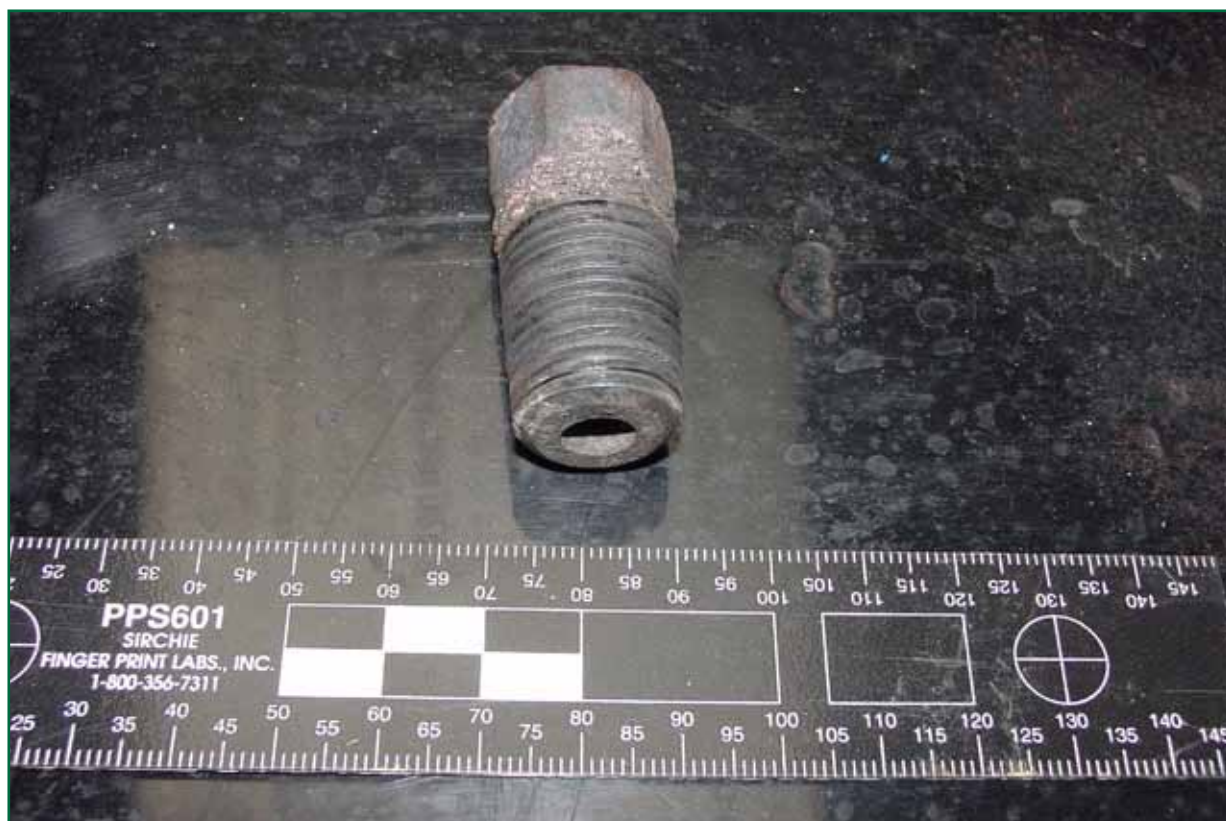
- 39 A threaded boss in the inner firebox *crownsheet* was fitted with a fusible plug. A fusible plug is a hollow threaded steel plug containing a core of a low melting point metal, such as lead<sup>1</sup>. Its purpose is to provide a warning of overheating of the firebox crownsheet by the melting of the core of the plug and consequent release of steam into the firebox. It does not prevent the firebox overheating, but is intended to give a warning so that action can be taken by the crew to prevent further damage. The appropriate action is to drop the fire. Figure 6 shows the fusible plug that was removed from the locomotive after the incident. The location of the plug in the firebox crownsheet is indicated in figure 7. The fusible plug was manufactured by the KLR to its own design and was installed in April 2010.

Figure 6: Fusible plug removed from 'Hawk'

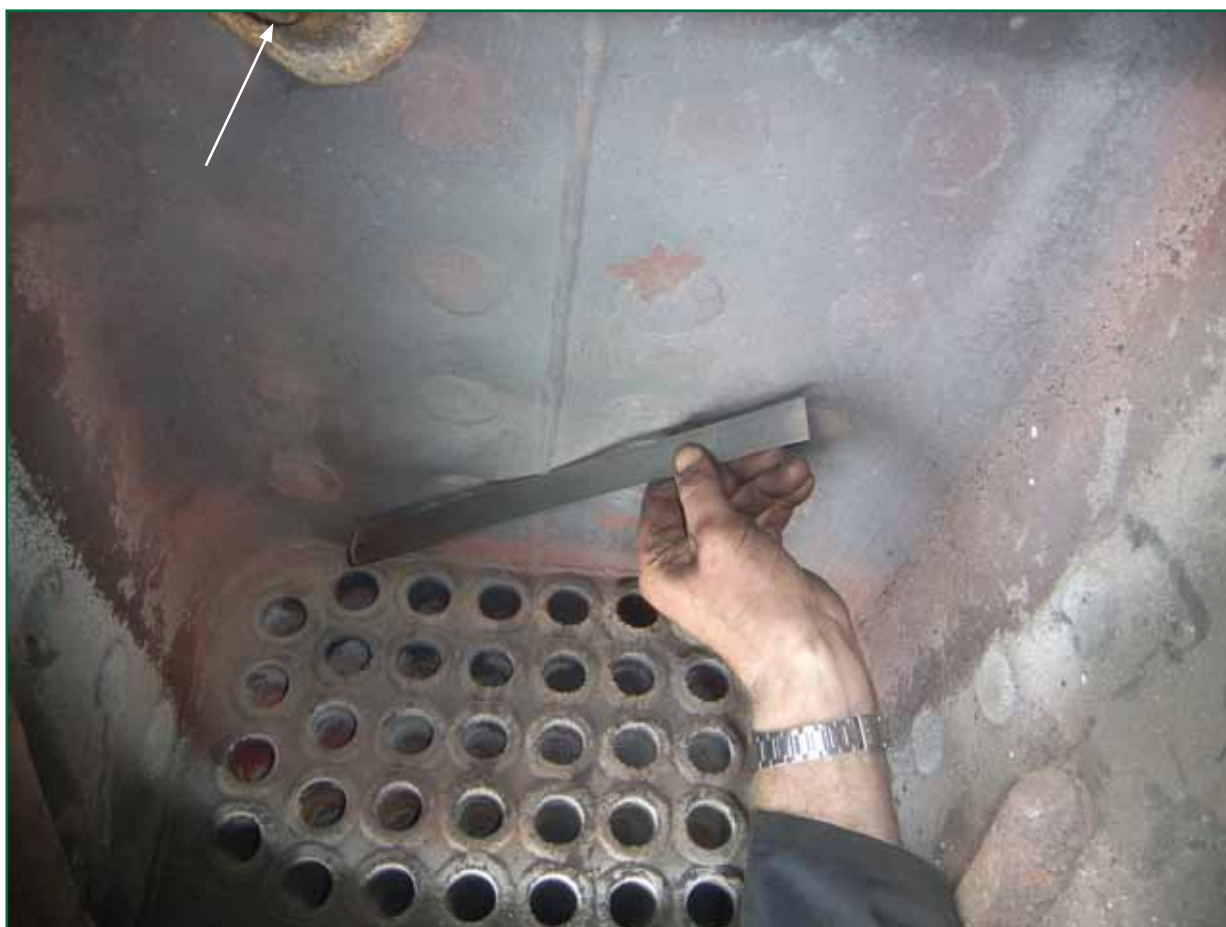
- 6 By the time the fire was dropped the boiler water level was below the top of the firebox, and the steam pressure had fallen from its normal operating pressure of 160 – 170 psi (11 – 11.7 bar) to around 100 psi (6.9 bar). The firebox was exposed to the heat of the fire without water behind it and suffered extensive damage as a result. Had the heat-softened metal in the top of the firebox ruptured there would have been a risk of serious injury to the train crew.

Figure 7: Interior of firebox showing scorch marks and quilting of the crown (location of fusible plug arrowed)

**50 The water level in the boiler was allowed to fall so low that the fusible plug melted and the firebox crown sheet was damaged. This was a causal factor in this incident.**
