# Rail Accident Report

## Boiler incident on the Kirklees Light Railway 3 July 2011

# Boiler incident on the Kirklees Light Railway

## 3 July 2011

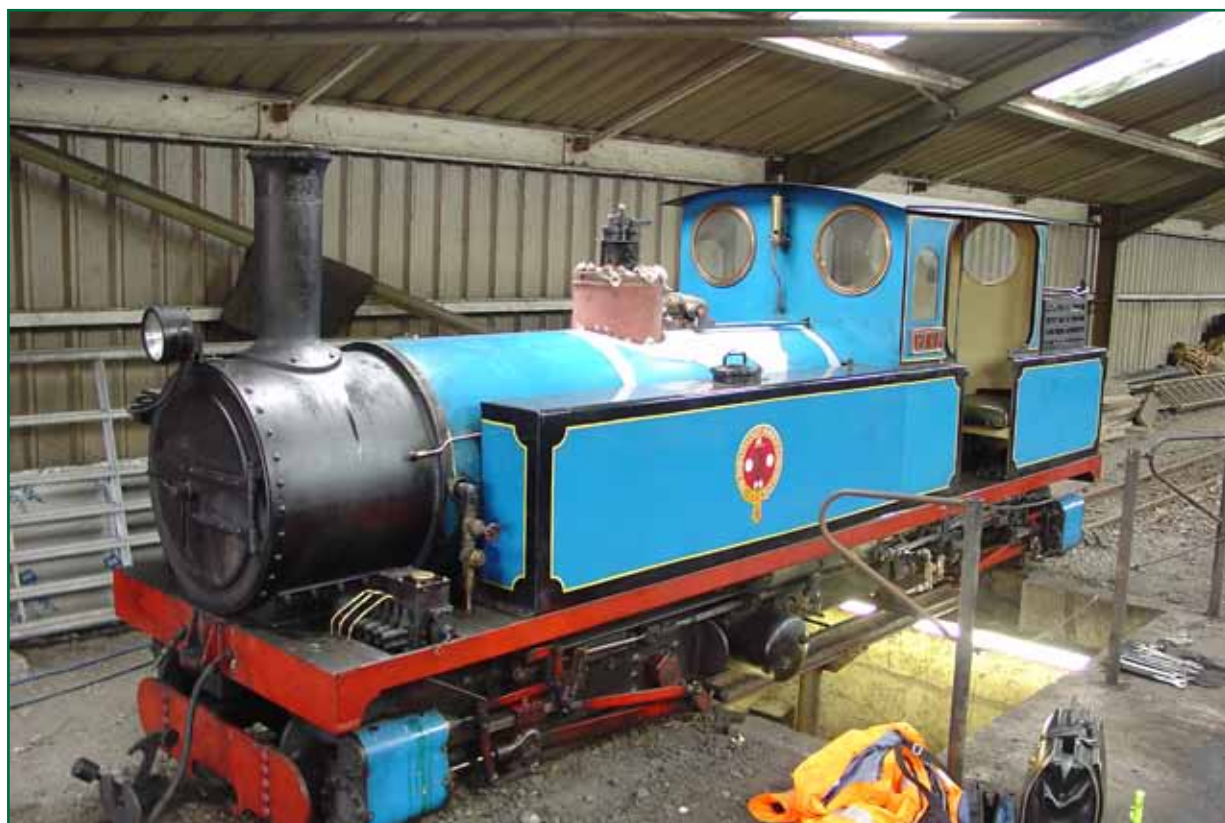
Figure 2: Locomotive 'Hawk' which was involved in the incident

- 14 The train involved was the 11:40 hrs departure from Clayton West to Shelley. This was the second passenger train of the day, but was the first to be hauled by the locomotive named 'Hawk' (figure 2). The train consisted of five passenger coaches and there were two train crew and between 25 and 30 passengers on board.

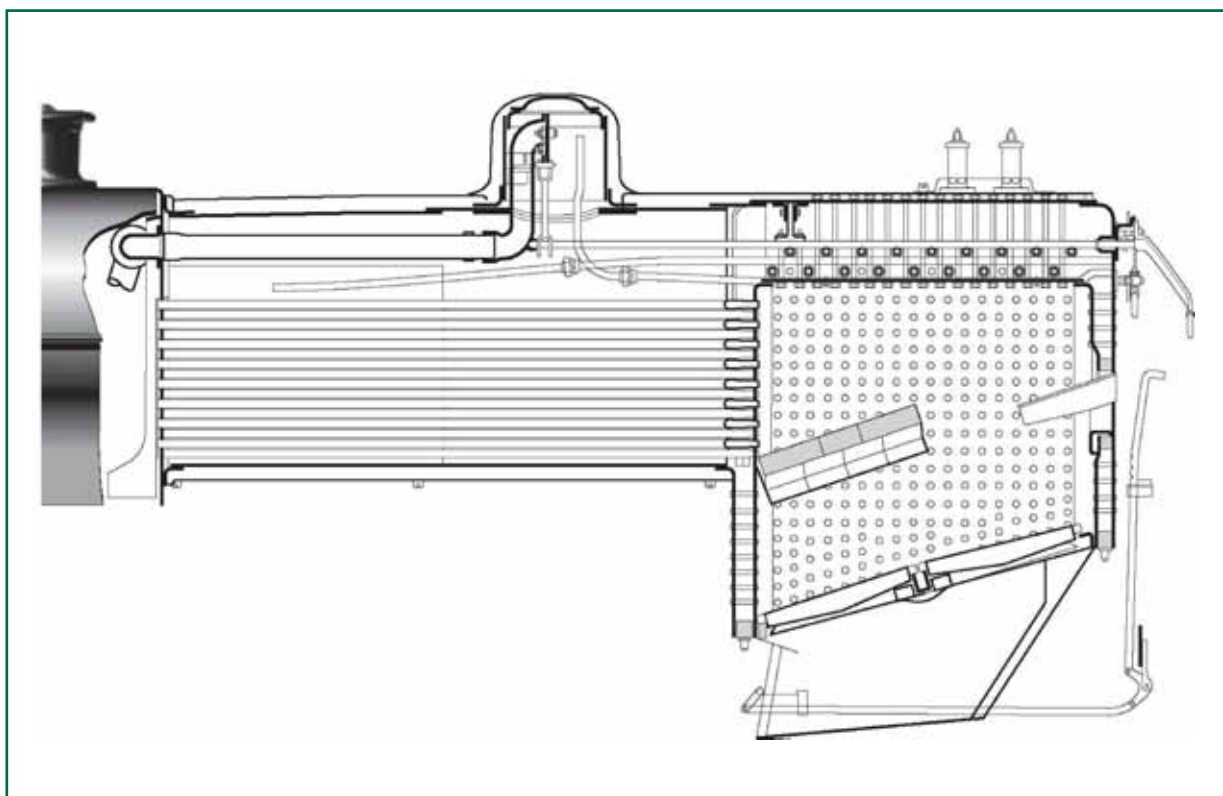
Figure 4: Diagram showing section through main line steam locomotive boiler (from ORR Railway Safety Publication 6, 'The Management of Steam Locomotive Boilers')

- 36 A steam locomotive boiler consists of two main parts, the barrel and the firebox. The boiler barrel of 'Hawk' consisted of a length of 24" (610 mm) diameter tube and was manufactured in 1997. The boiler barrel contained 42 boiler tubes, which ran longitudinally from the firebox to the *smokebox* (figure 4). These tubes carry hot gas from the fire and, during its passage through the tubes, the gas gives up heat to the water.
